## Bias-Tee, 5 kHz – 1.2 GHz, 5 - 10A

### 1 Introduction

The TBBT01 Bias-Tee is a device for measuring the saturation effects of power inductors and bias voltage effects on capacitors. The majority of available Bias-Tees for power inductor testing operate at low frequencies, rendering them unsuitable for evaluating decoupling/bias inductors of RF power amplifiers or EMC filters. However, RF Bias-Tees usually have restricted current capabilities and cannot be employed in the lower frequency region. The TBBT01 can measure high bandwidth as well as high current.

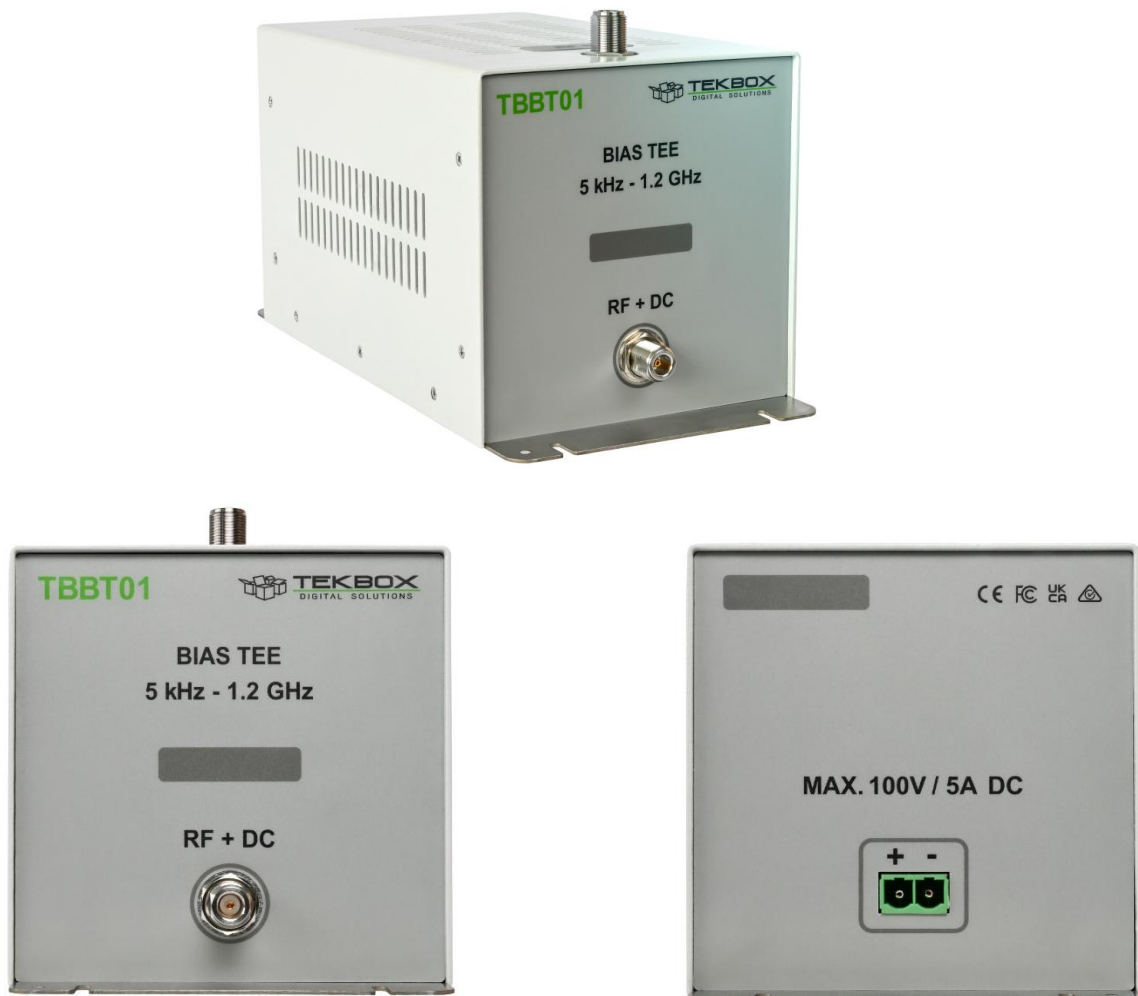
The TBBT01 can inject up to 10A DC current into a 50 Ohm RF-path and operates at frequencies between 5 kHz and 1.5 GHz.

The TBBT01's insertion loss is unrelated to injection current.

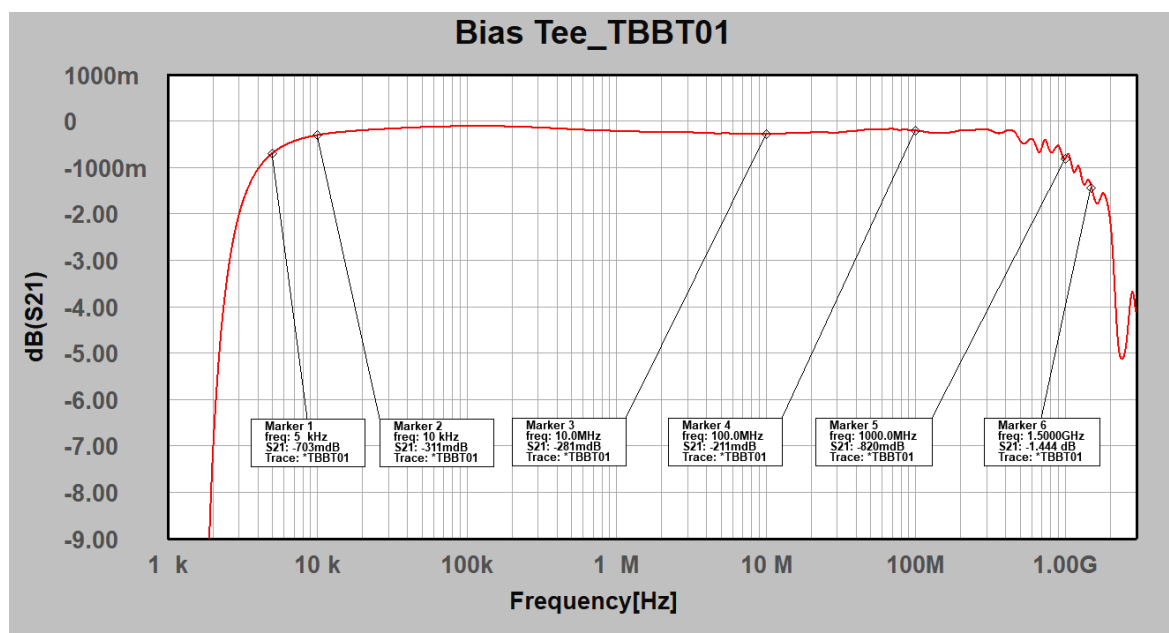
### 3 Insertion loss

*TBBT01, Insertion Loss, 1 kHz – 3 GHz*

| RF path insertion loss: | <1 dB typ. in the range 10 kHz – 1 GHz<br>< 1.5 dB in the range 5 kHz – 1.2 GHz |

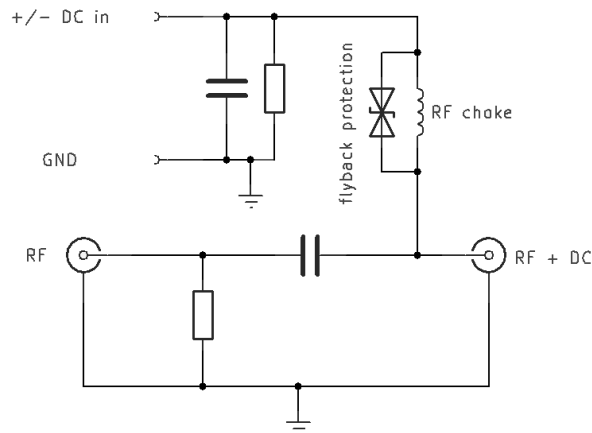
### 4 Principle schematic

*Simplified schematic of the TBBT01*

- 1) The TBBT01 bias path contains high inductance chokes, which could create flyback voltage spikes. As a result, the Bias Tee is designed with transient suppressors fitted across the choke terminals.
- 2) When operating the device at high voltages, the coupling capacitor potentially could inject high voltage into the RF-path. This could be avoided by connecting a transient suppressor between RF path and ground. However, suppressors with a short turn on time and low capacitance are susceptible to high energy pulses and tend to short out, necessitating Bias-Tee repair. Furthermore, the Bias-Tee could not handle high RF power with such suppressors in place. As a result, the RF path of the TBBT01 is not equipped with any transient suppressors. Thus, avoid rapidly switching high external supply voltages on and off.

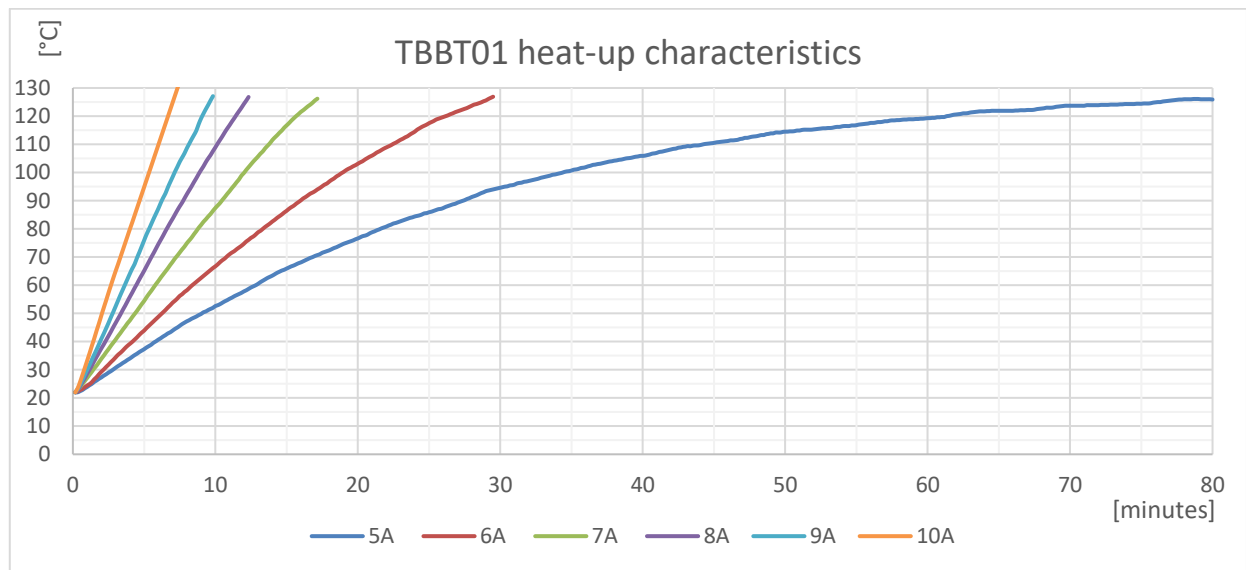
### 6 Thermal characteristics

*Coil temperature vs. current*

Limit the measurement time to keep the coil temperature below 125°C

| Operating current range: | $\pm 5$ A to 10 A DC; see heat up characteristics plot<br>$\pm 5$ A DC continuous<br>max. $\pm 15$ A DC |

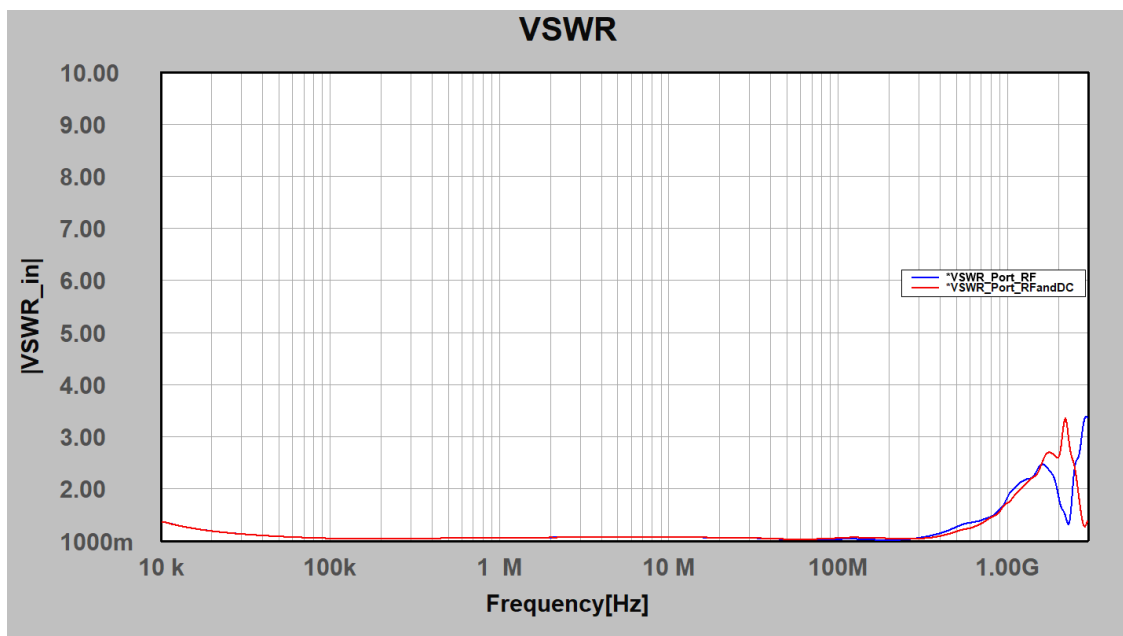
### 7 VSWR

*VSWR; Port RF, PORT RF+DC*

| VSWR: | 1 < VSWR < 2 in the range 5 kHz to 1 GHz |

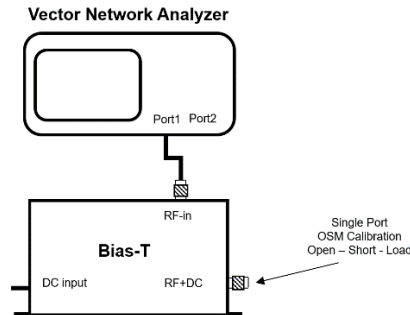
- 1) Connect a Vector Network Analyzer to the RF-port of the Bias-Tee. Carry out an OSL calibration at the RF+DC - port of the Bias-Tee.

Calibration setup

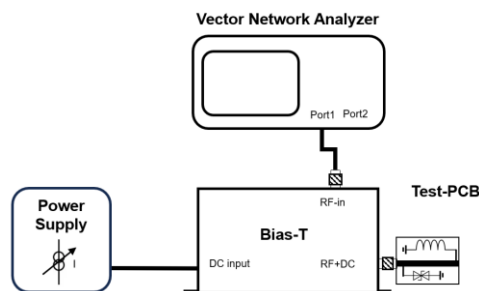
- 2) Connect a test PCB with the inductor to the RF+DC port. Depending on coaxial couplers and the length of the PCB, you may enter a suitable electrical delay to shift the “Open” to the end of the transmission line on the test PCB. Solder the inductor to the test PCB and carry out impedance measurements for various bias currents.

Measurement setup

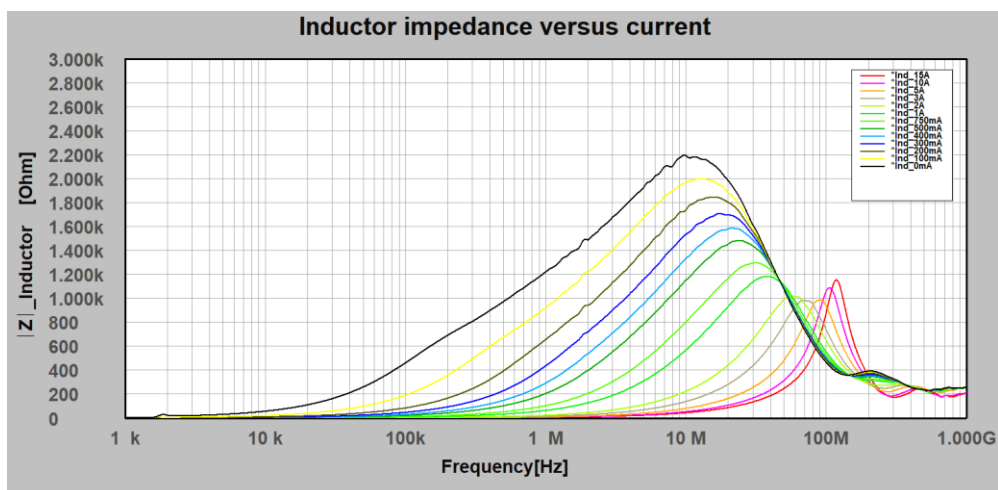
Impedance of an inductor vs. current; 10 turns on a FT-100A-75 torroid core; 0 – 15 A

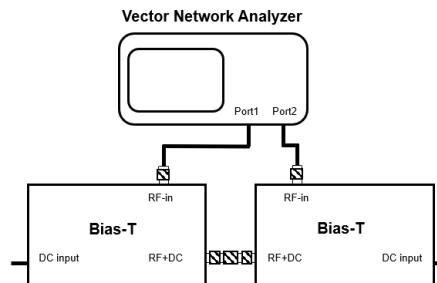
- 1) Connect two Bias-Tees using coaxial adapters as depicted below and make a through calibration

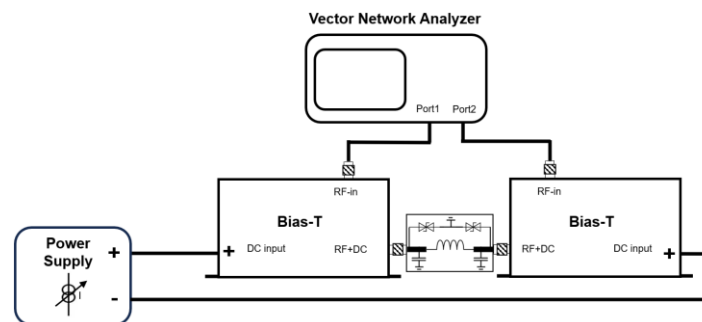
- 2) Connect the test PCB with the EMC-filter in between two Bias-Tees and measure S21 for various bias currents

Note that the EMC – Filter is measured in a 50 Ohm system. In real applications, the filter is terminated with the source and load impedance.

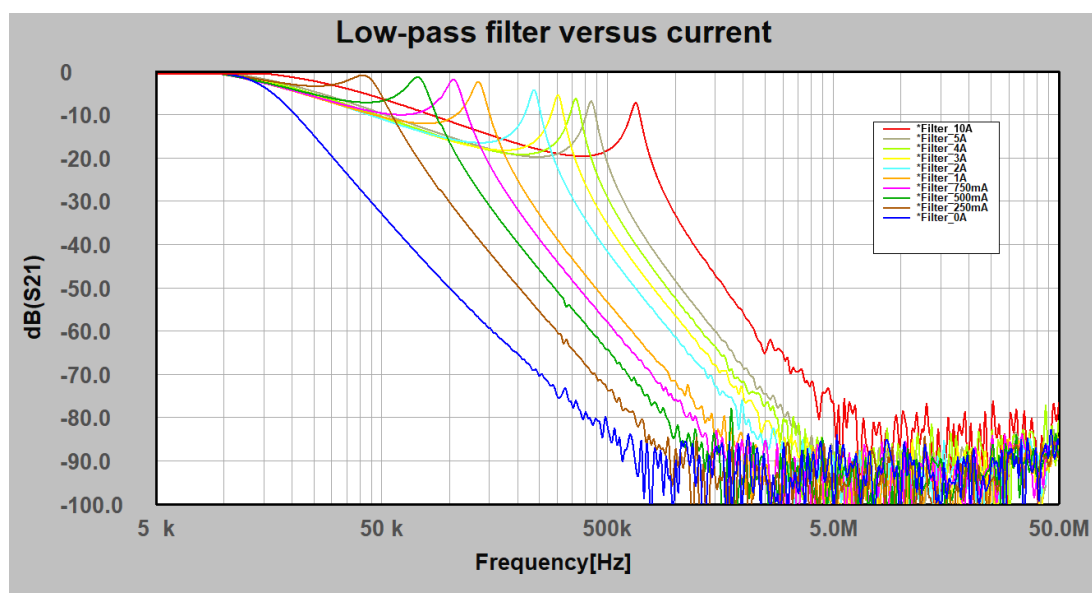
EMC low-pass filter characteristics; 0 – 10A load current

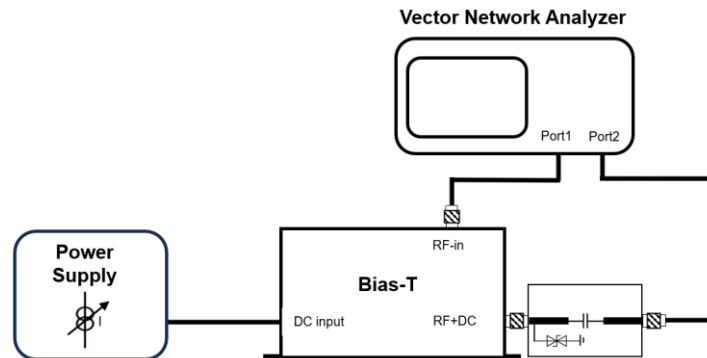
- 1) To investigate suitability of an RF choke for a RF power amplifier output transistor, make a through calibration of a setup as depicted below.

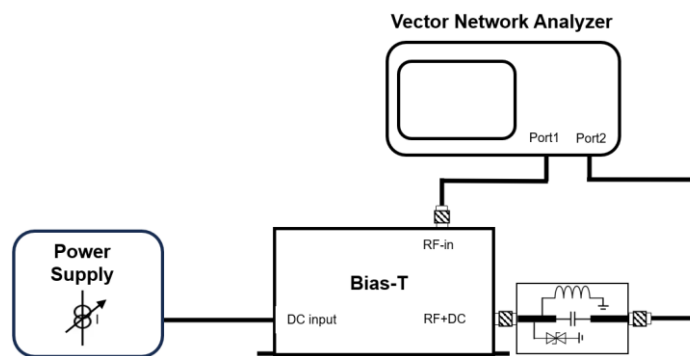
- 2) Next add the RF choke and measure its effect on the S21 of the output path.

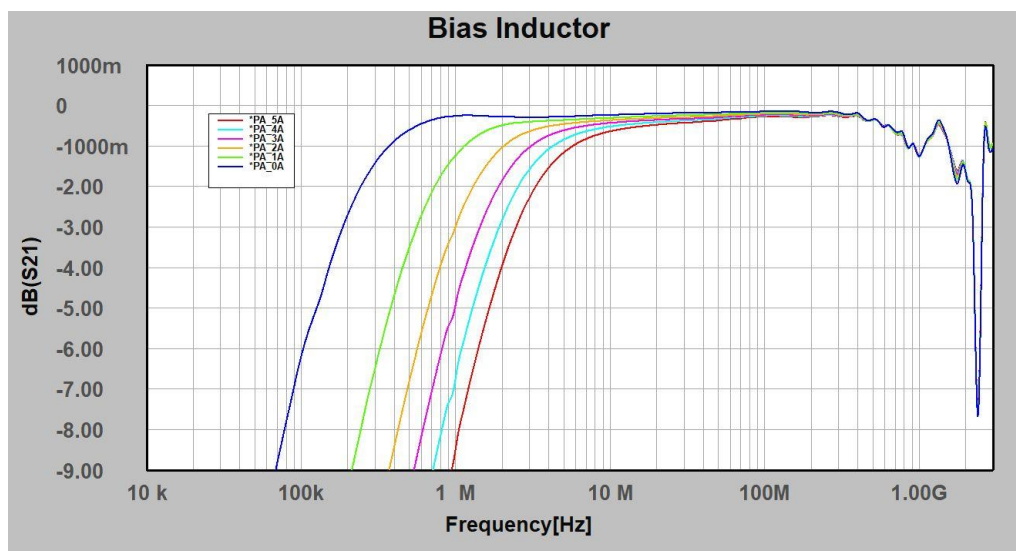
*Insertion loss caused by an RF choke; 5 turns on a 43 material core 5943007601; 0 to 5A*

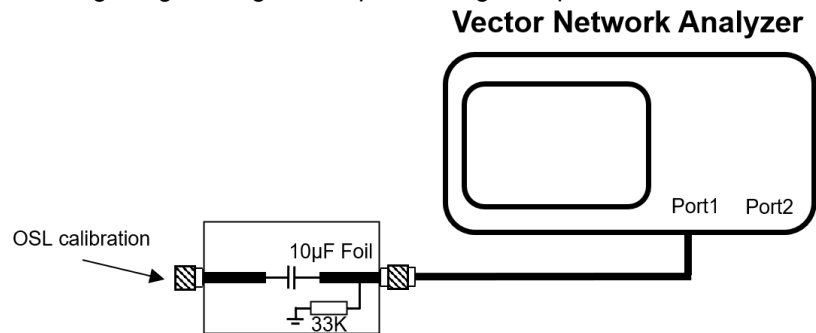
- 1) To investigate capacitance versus bias voltage, prepare a test PCB as depicted below and perform a single channel S11 OSL calibration at low frequency, e.g. from 10kHz – 15kHz. As decoupling capacitor, use a large, high voltage foil capacitor; e.g.  $\geq 10\mu\text{F} / 200\text{V}$

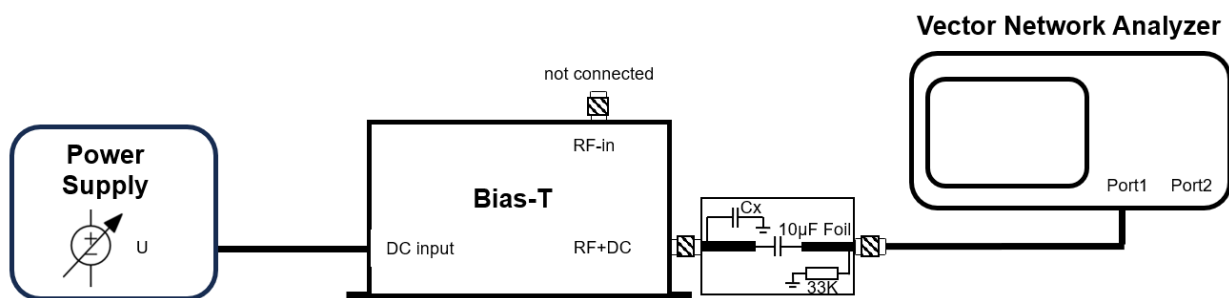
- 2) Solder the capacitor under test to the test-PCB as depicted below and measure the capacitance (imaginary part of S11) for various bias voltages

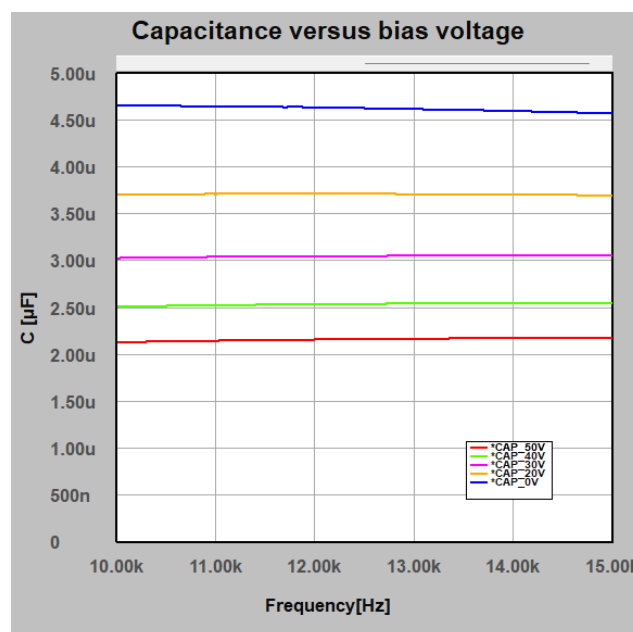
Capacitance variation versus bias voltage;  $4.7\mu\text{F}/50\text{V}$ , X7R, 1206; CL31B475KBHVPNE
